Catalytic Converter Failures

If a catalytic converter needs replacing, one of the problems below most likely contributed to its failure.

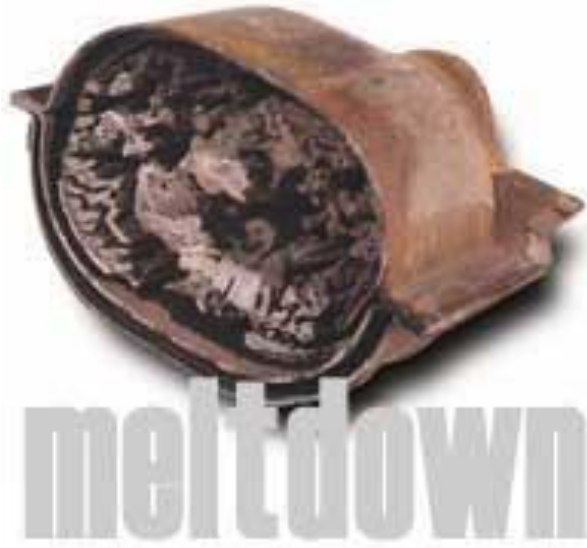
Converter Meltdown.

This is an example of a converter meltdown. The converter was super-heated due to a raw fuel condition in the exhaust flow. The excess unburned fuel ignited when it struck the hot ceramic catalyst and drove the temperature far above the normal operating condition of the converter. The ceramic catalyst is unable to withstand the extremely high temperature and begins to melt. The ceramic collapses and the converter is destroyed. The melted ceramic may block the exhaust flow and cause additional damage to the engine. A converter glowing red-hot, or evidence of heat discoloration, confirms this situation.

The condition that led to this converter meltdown could be the result of a number of malfunctions including faulty oxygen sensor, an incorrect fuel mixture, worn spark plugs or plug wires, a faulty check valve, incorrect ignition timing, sticking float, faulty fuel injectors or other ignition malfunctions

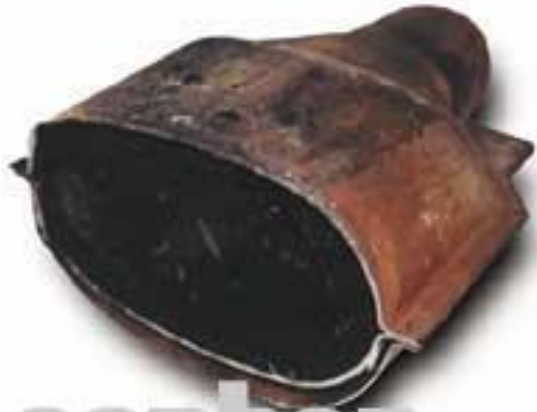
Carbon Deposits.

carbon

This is an example of a converter with carbon deposits in the ceramic catalyst. This is usually a result of oil or antifreeze entering the exhaust system or a too-rich fuel mixture. The heavy carbon deposit clogs the converter and reduces exhaust flow. This increases backpressure and causes the entire exhaust system to heat up. The heat backs up into the engine compartment and may result in a number of heat-related engine problems.

Mild carbon scoring may do less damage to engine components but it may seriously affect the converter's ability to reduce harmful emissions. It could easily cause a vehicle to fail an emission test. Carbon deposits may be the result of faulty valves, worn piston rings, worn or leaking gaskets or lead in the fuel.

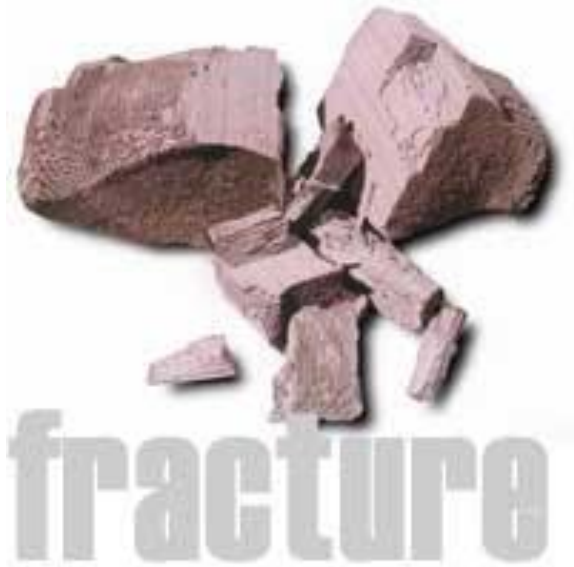
Catalyst Fracture.

This is an example of a catalyst fracture. The ceramic became loose, cracked and began to break down. The pieces began to obstruct flow, creating backpressure and increasing the heat in the exhaust system. There is evidence of a partial meltdown in this example due to overheating.

The initial cause for this damage could have been road debris striking the converter based on evidence of impact on the converter shell. In some cases, if the protective mat that holds the catalyst in place is directly exposed to exhaust gasses, it could deteriorate and allow the catalyst to fracture. The Car Sound converter uses two recessed cavities in the body to hold the protective mat out of the exhaust flow to prevent any deterioration. The mat stays in place and the catalyst is held firm.
